# calm after the Storm

## Stainless steel enclosure withstands Hurricane Gustav, protects electrical equipment at a Louisiana utility plant

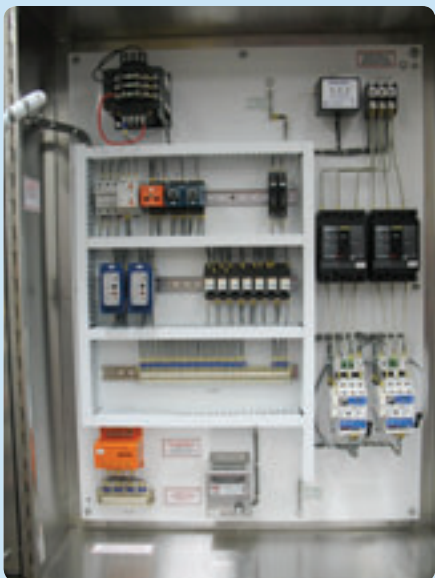
Hurricane Gustav storms left the plant's controls enclosure three-quarters underwater.

Once Hurricane Gustav struck the utility plant, the building suffered from significant long-term flooding. The enclosure, which contained the plant's duplex pump control panel and electrical motor controls, was three-quarters underwater.

"The Type 4X stainless steel enclosure was located in a pit that filled up with water, submerging the panel," Sigmon said. "We're not sure for how long, but it could have been underwater for days."

"We opened the panel, and we could see no evidence of water entry," Sigmon said. "The enclosure is not rated for submersion, so we expected to see equipment damage. But we tested the electrical equipment,

"We've had enclosures submerged before, but they were totally destroyed when water entered," Sigmon said. "We could tell where the water level was at the plant because the outside of the panel was filthy, but the enclosure and electrical equipment were fully functional. The stainless steel enclosure had sustained more damage from the plant shipping it back to us than it did from the storm."
